PCS03:
NFRC PROJECT CASE STUDY

Overlaying an Asbestos Cement Roof

Commercial unit, Harrogate

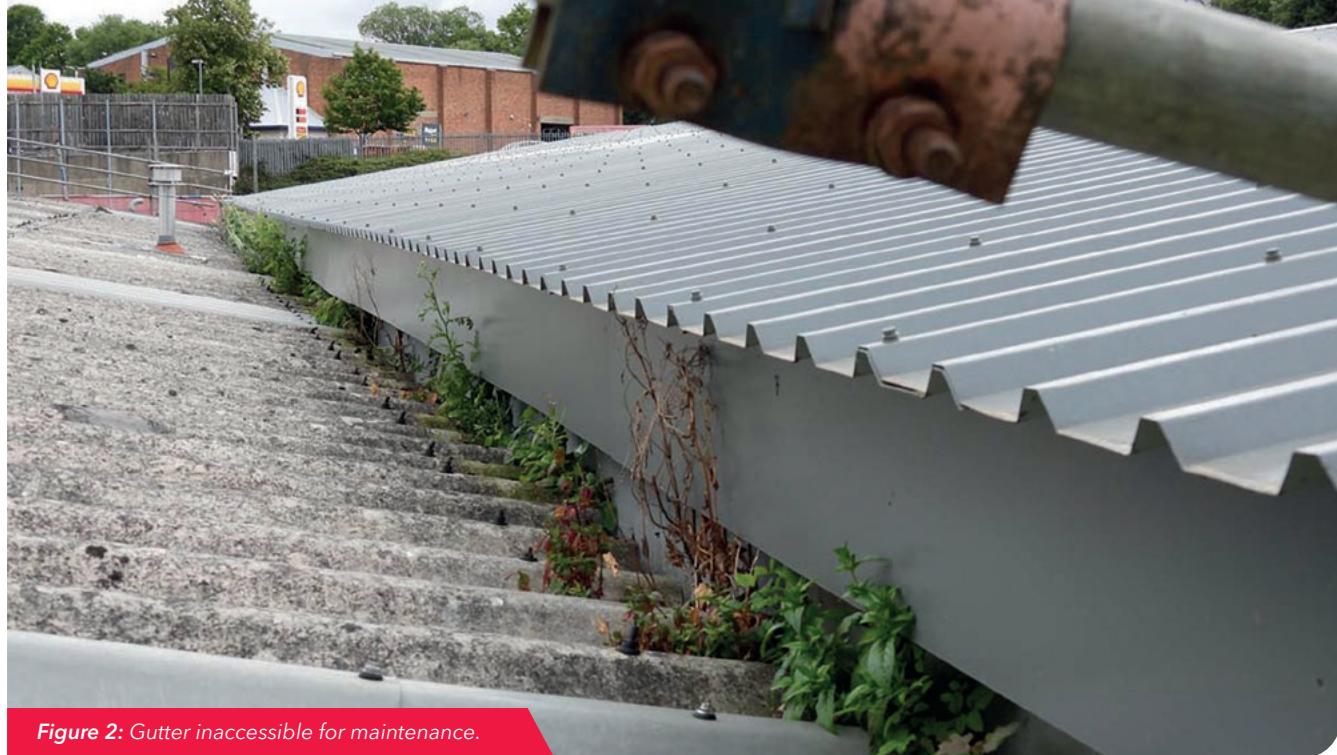
Figure 2: Gutter inaccessible for maintenance.

Overlay system design needed to consider existing structural load capabilities and to allow gutter access maintenance (figure 2).

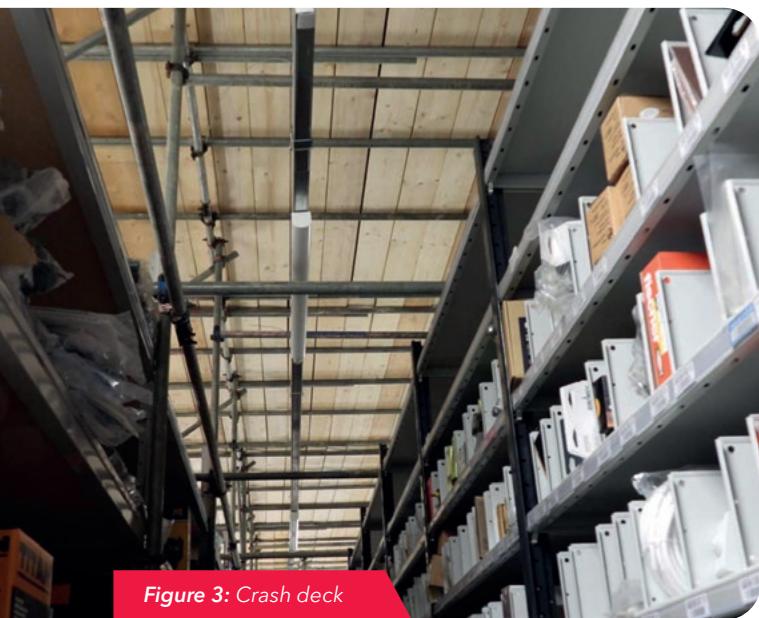
Figure 3: Crash deck

- Exclusion zones were created, with high-visibility signage and fencing.
- A crash deck scaffold (*figure 3*) was erected internally beneath the roof work area to protect staff and customers from falling objects.
- The crash deck was sealed using high-density polythene sheeting to prevent debris and dust ingress.
- The crash deck was erected at night in phases, directly below the roof, allowing the store to remain operational (*figure 4*).
- Remote air monitoring equipment was placed between the crash deck and roof sheets.

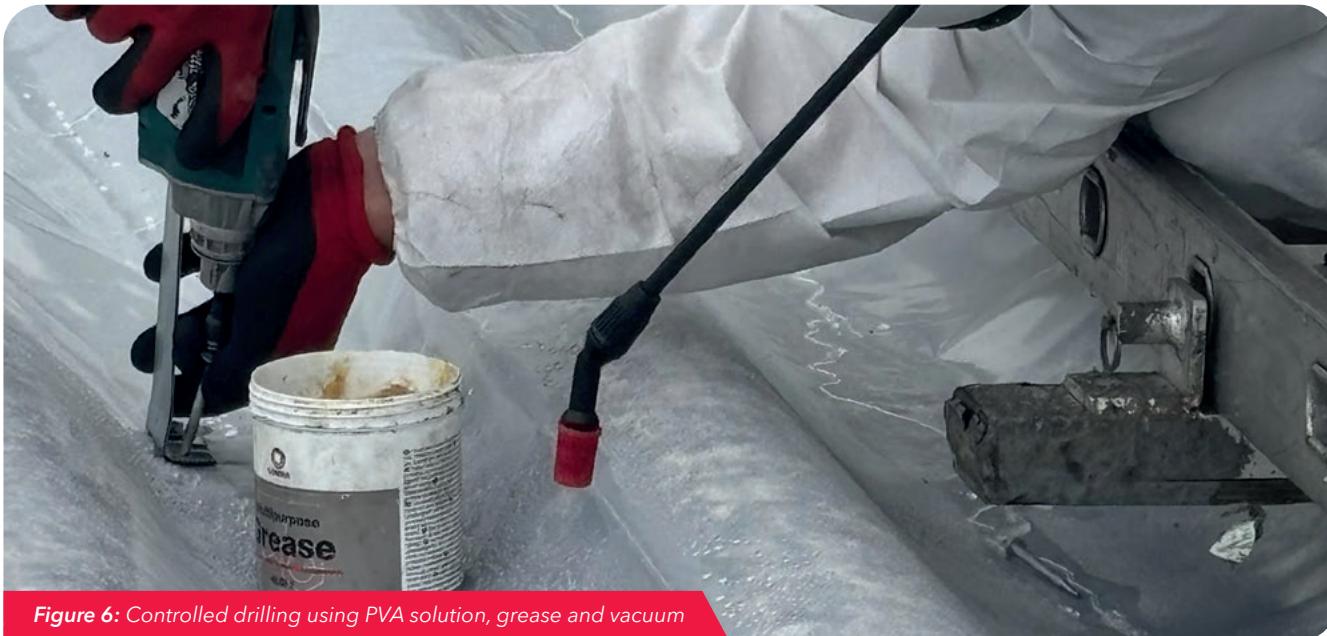
Figure 6: Controlled drilling using PVA solution, grease and vacuum

- An Asbestos Survey was carried out to confirm the type, condition, and extent of asbestos cement.
- The asbestos cement sheets were left undisturbed; fixings for the rail system were designed to go through the existing sheets into structural purlins below, avoiding any removal of the asbestos.
- All drilling was carried out using pre-approved methods (*figure 6*).
- All operatives received asbestos training in compliance with the Control of Asbestos Regulations 2012 (CAR 2012).
- A watching brief and air monitoring were implemented during intrusive works (*figure 7*).

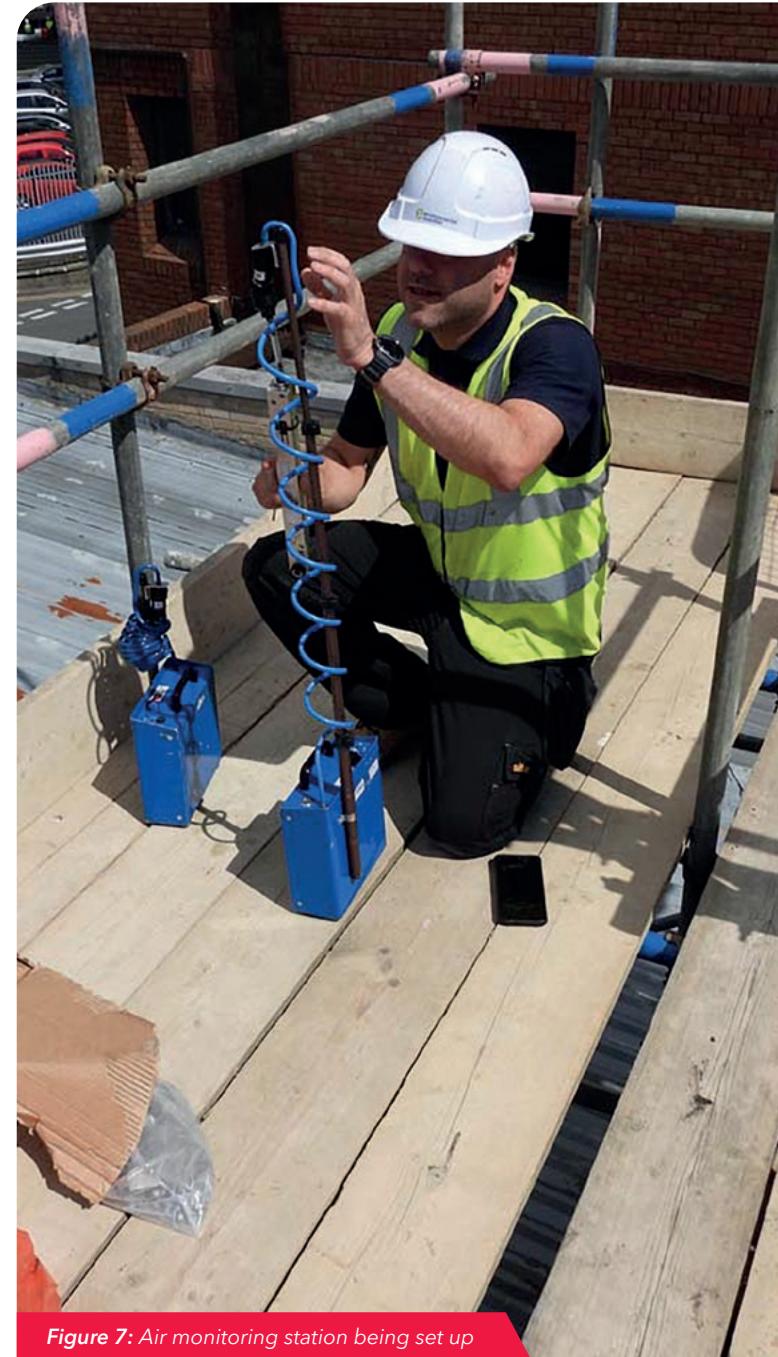
Figure 7: Air monitoring station being set up

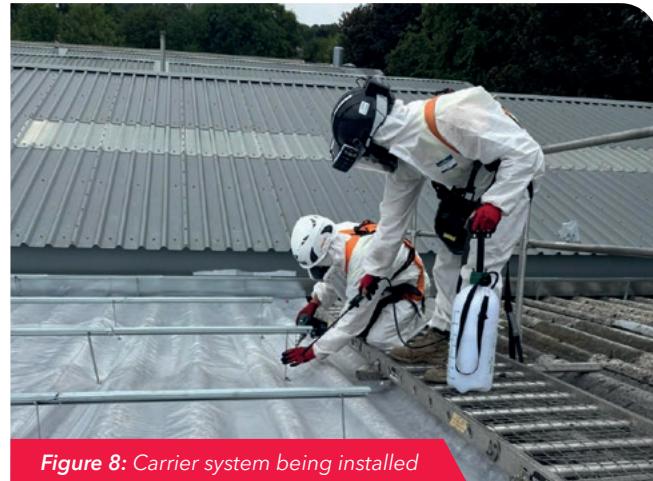
Figure 8: Carrier system being installed

- Brackets fixed through existing sheets into purlins using approved fixings (*figure 8*).
- Dust extraction/elimination in use at all times.
- Fasteners used for the brackets were coated in light grease prior to penetrating the asbestos roof sheet.
- Location of the brackets were coated in a diluted PVA solution prior to the fasteners being installed to encapsulate any fibres released.
- Rails installed to create sub-structure for new roof.

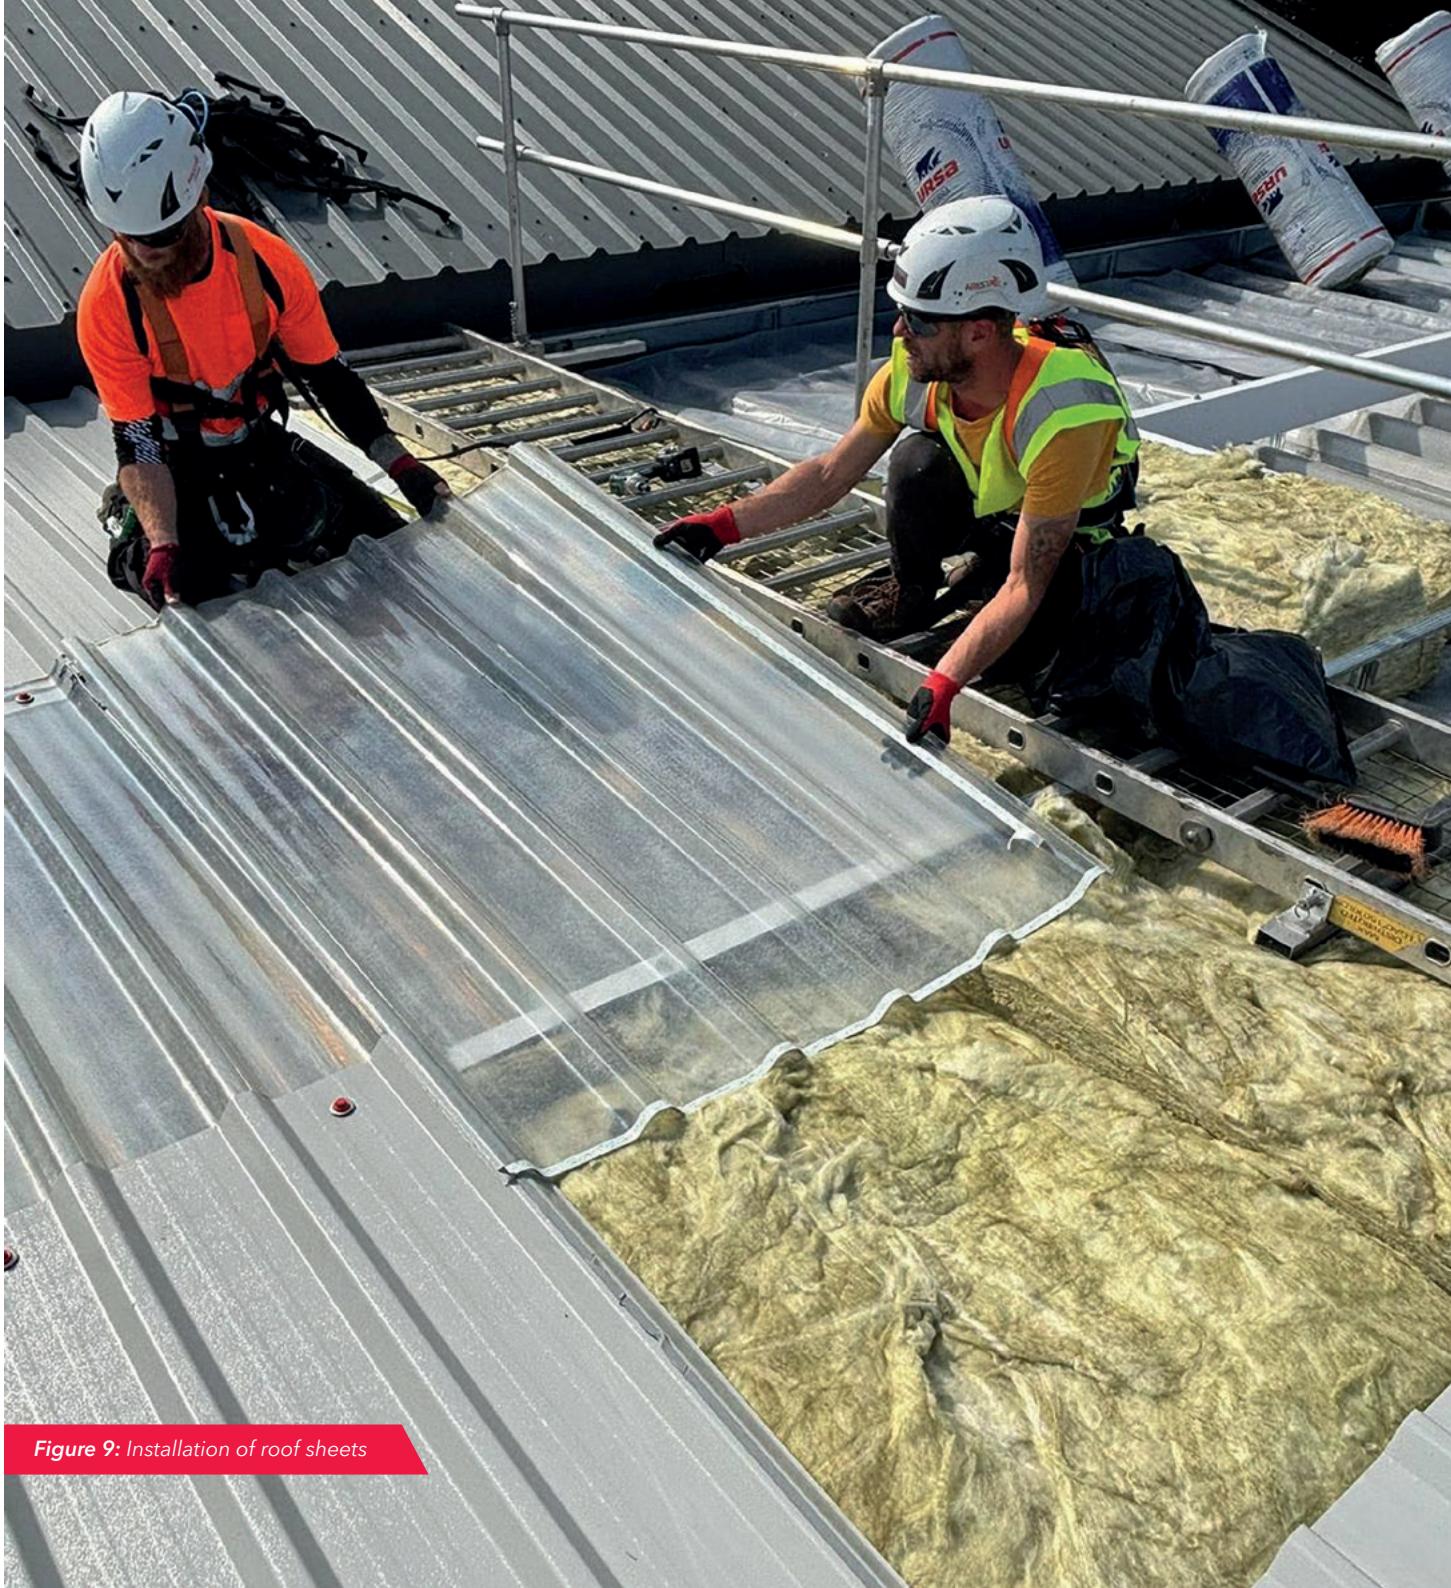
Figure 9: Installation of roof sheets

- Air and Vapour Control Layer (AVCL) installed and fully sealed.
- Mineral wool insulation laid tightly butt-jointed under the rails (*figure 9*).

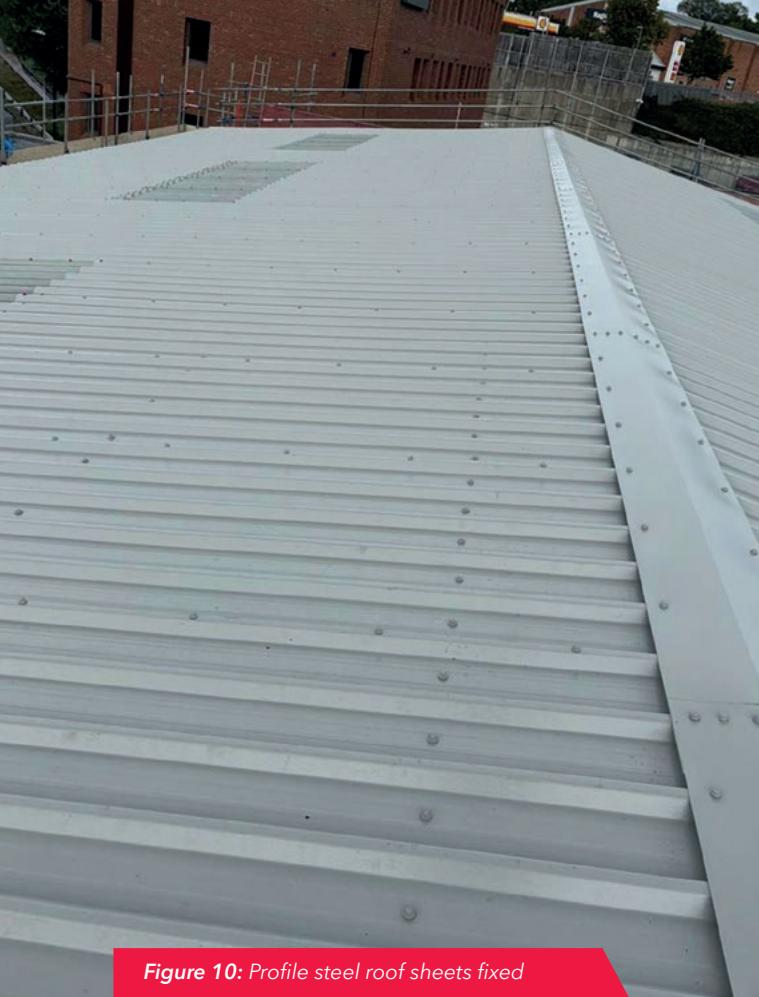
Figure 10: Profile steel roof sheets fixed

- Trapezoidal steel sheeting fixed to rails with self-drilling fixings.
- Eaves and ridge flashings installed to complete the system (figure 10).
