PCS03:
NFRC PROJECT CASE STUDY

Overlaying an Asbestos Cement Roof

Screwfix Store, Harrogate

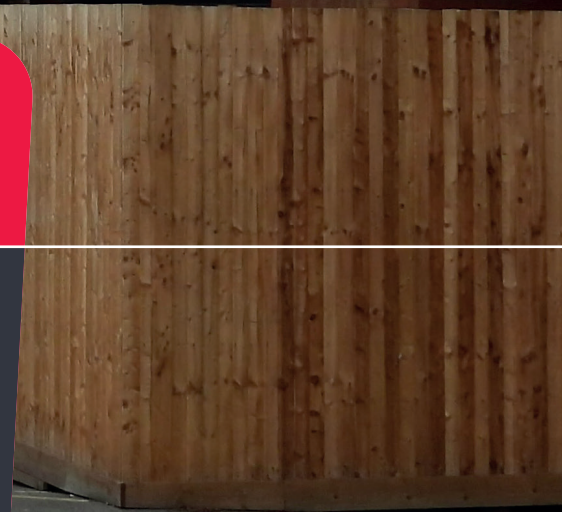
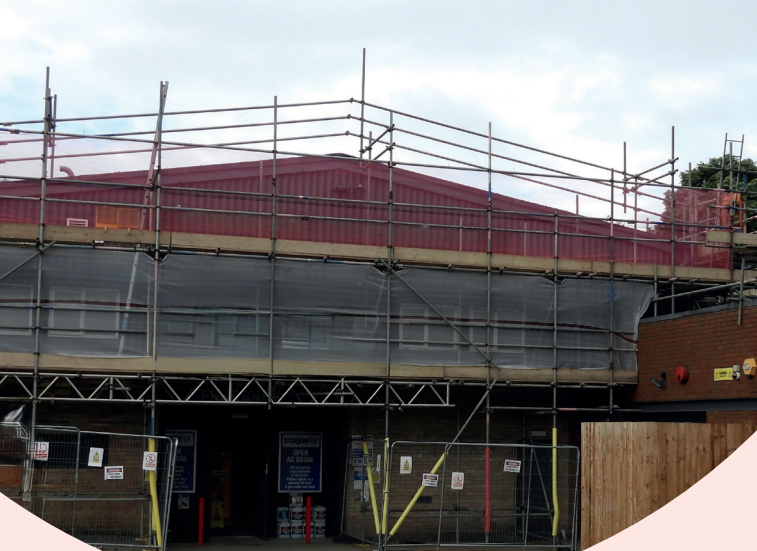
Figure 1: Store frontage scaffolding to allow public access to and from the store

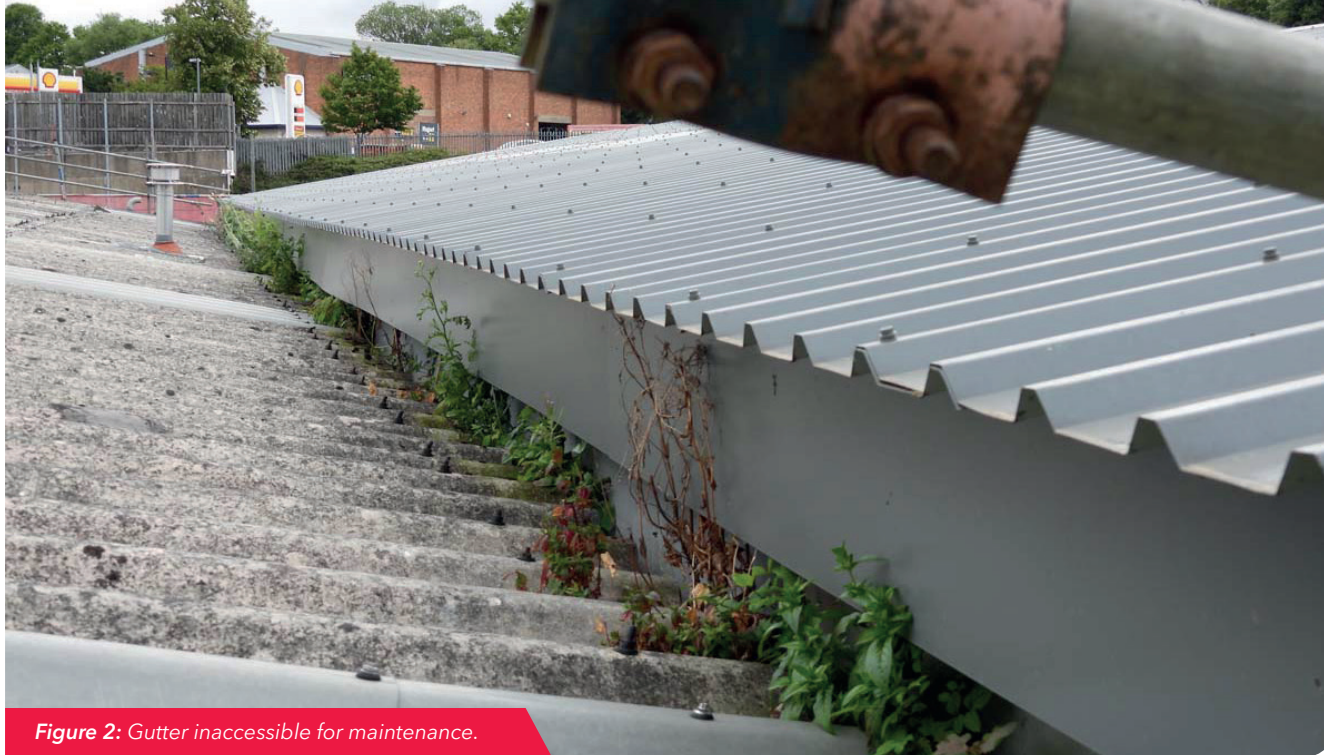
Figure 2: Gutter inaccessible for maintenance.

Overlay system design needed to consider existing structural load capabilities and to allow gutter access maintenance (*figure 2*).

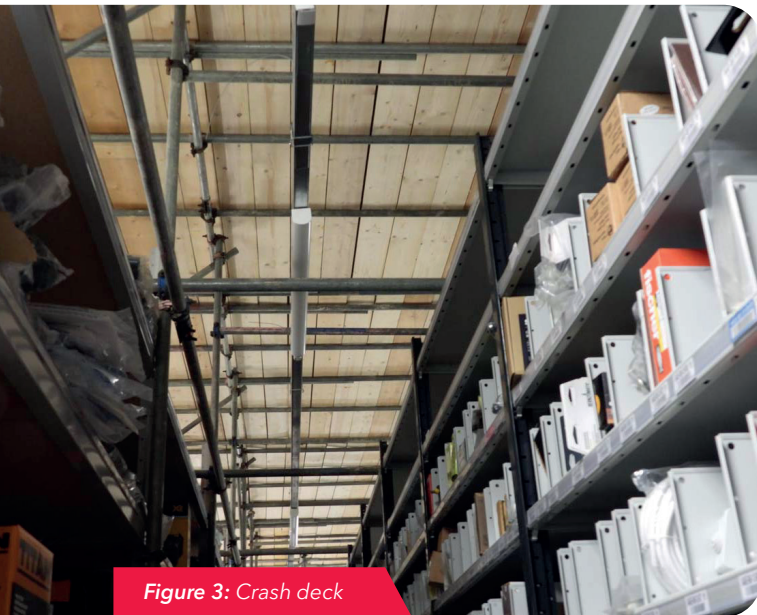
Figure 3: Crash deck

- Exclusion zones were created, with high-visibility signage and fencing.
- A crash deck scaffold (*figure 3*) was erected internally beneath the roof work area to protect staff and customers from falling objects.
- The crash deck was sealed using high-density polythene sheeting to prevent debris and dust ingress.
- The crash deck was erected at night in phases, directly below the roof, allowing the store to remain operational (*figure 4*).
- Remote air monitoring equipment was placed between the crash deck and roof sheets.

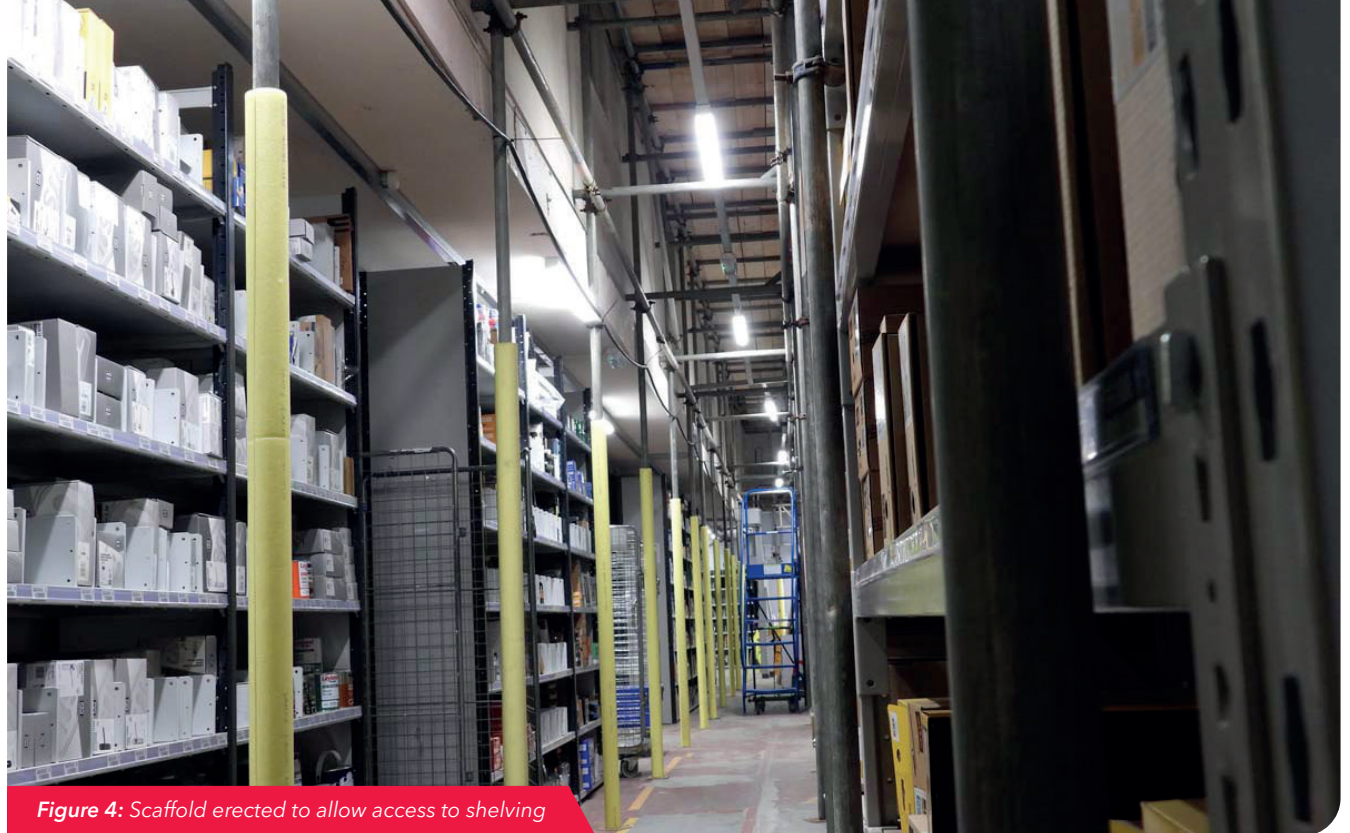
Figure 4: Scaffold erected to allow access to shelving

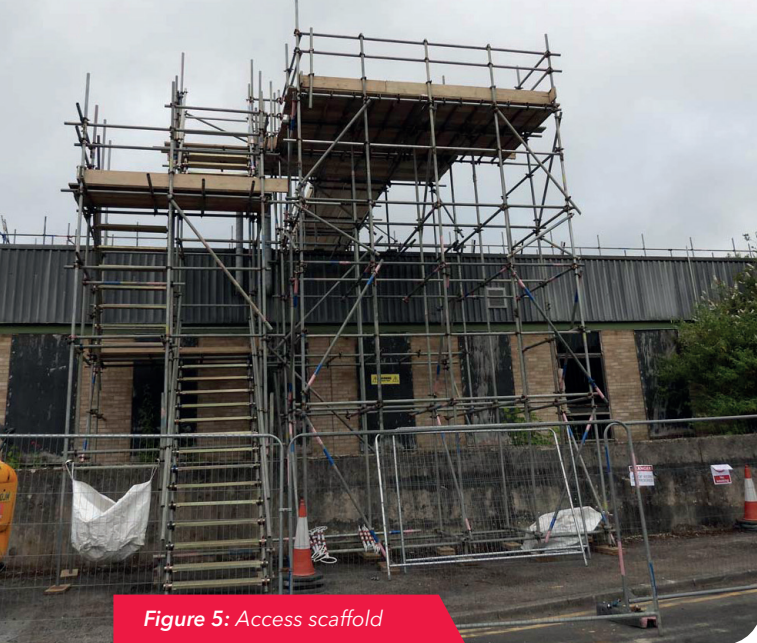
Figure 5: Access scaffold

- A full edge protection working platform system was installed before work commenced.
- Non-fragile access systems including walk boards and temporary roof platforms were used to avoid loading the fragile roof surface.
- Operatives used fall arrest harnesses and were trained in rescue procedures.
- Material handling was designed to reduce manual handling at height through mechanical hoists and roof loading platforms.

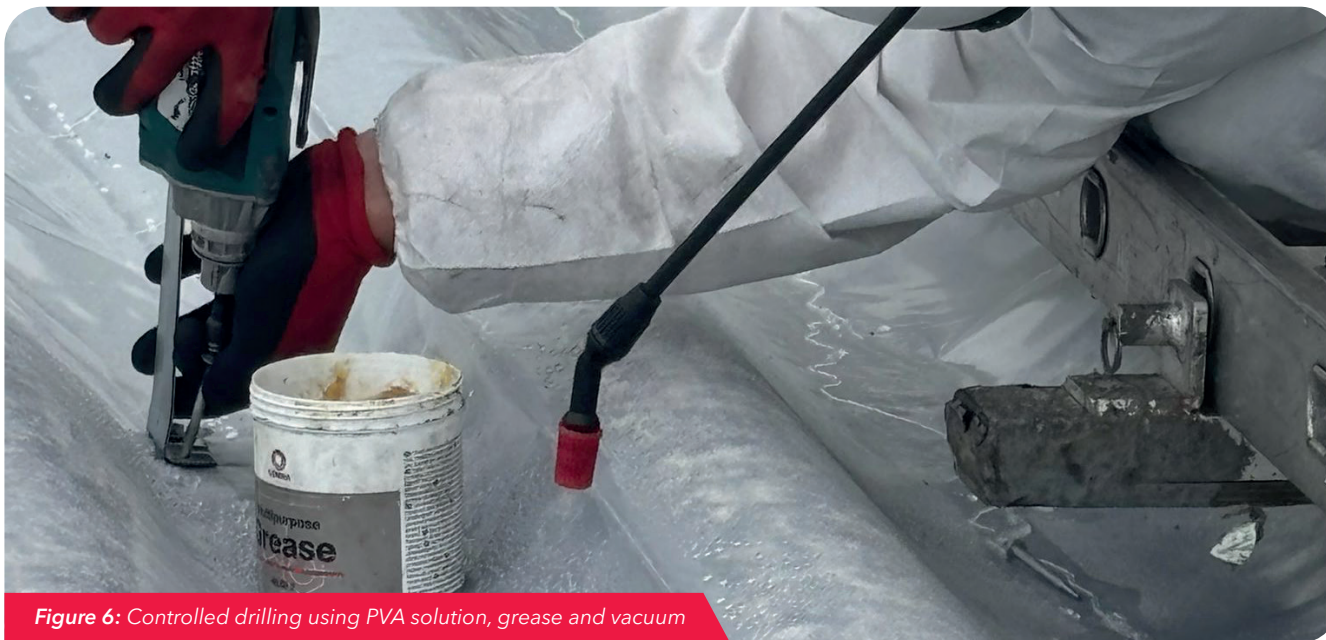
Figure 6: Controlled drilling using PVA solution, grease and vacuum

- An Asbestos Survey was carried out to confirm the type, condition, and extent of asbestos cement.
- The asbestos cement sheets were left undisturbed; fixings for the rail system were designed to go through the existing sheets into structural purlins below, avoiding any removal of the asbestos.
- All drilling was carried out using pre-approved methods (figure 6).
- All operatives received asbestos training in compliance with the Control of Asbestos Regulations 2012 (CAR 2012).
- A watching brief and air monitoring were implemented during intrusive works (figure 7).

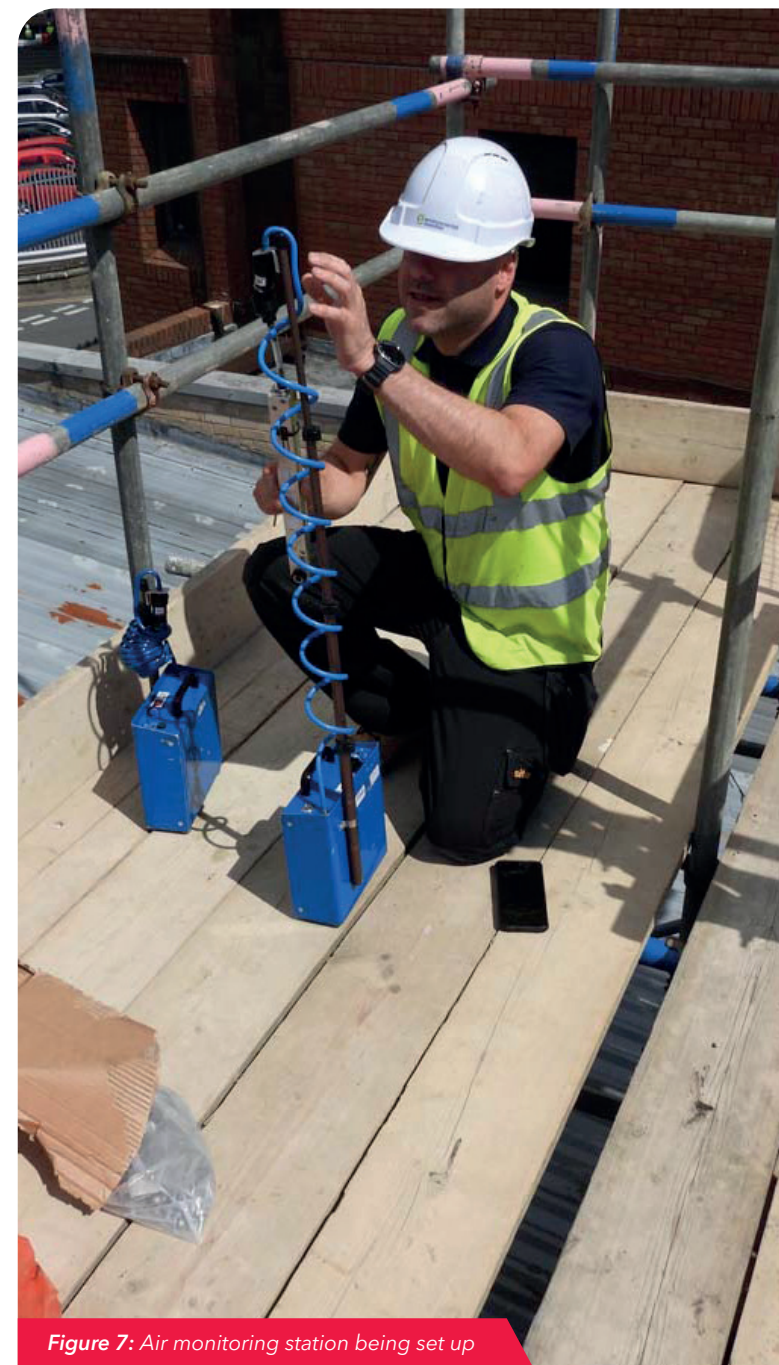
Figure 7: Air monitoring station being set up

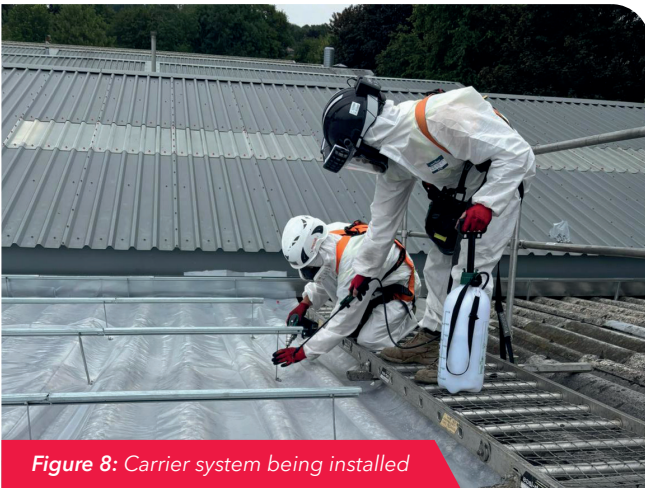
Figure 8: Carrier system being installed

- Brackets fixed through existing sheets into purlins using approved fixings (*figure 8*).
- Dust extraction/elimination in use at all times.
- Fasteners used for the brackets were coated in light grease prior to penetrating the asbestos roof sheet.
- Location of the brackets were coated in a diluted PVA solution prior to the fasteners being installed to encapsulate any fibres released.
- Rails installed to create sub-structure for new roof.

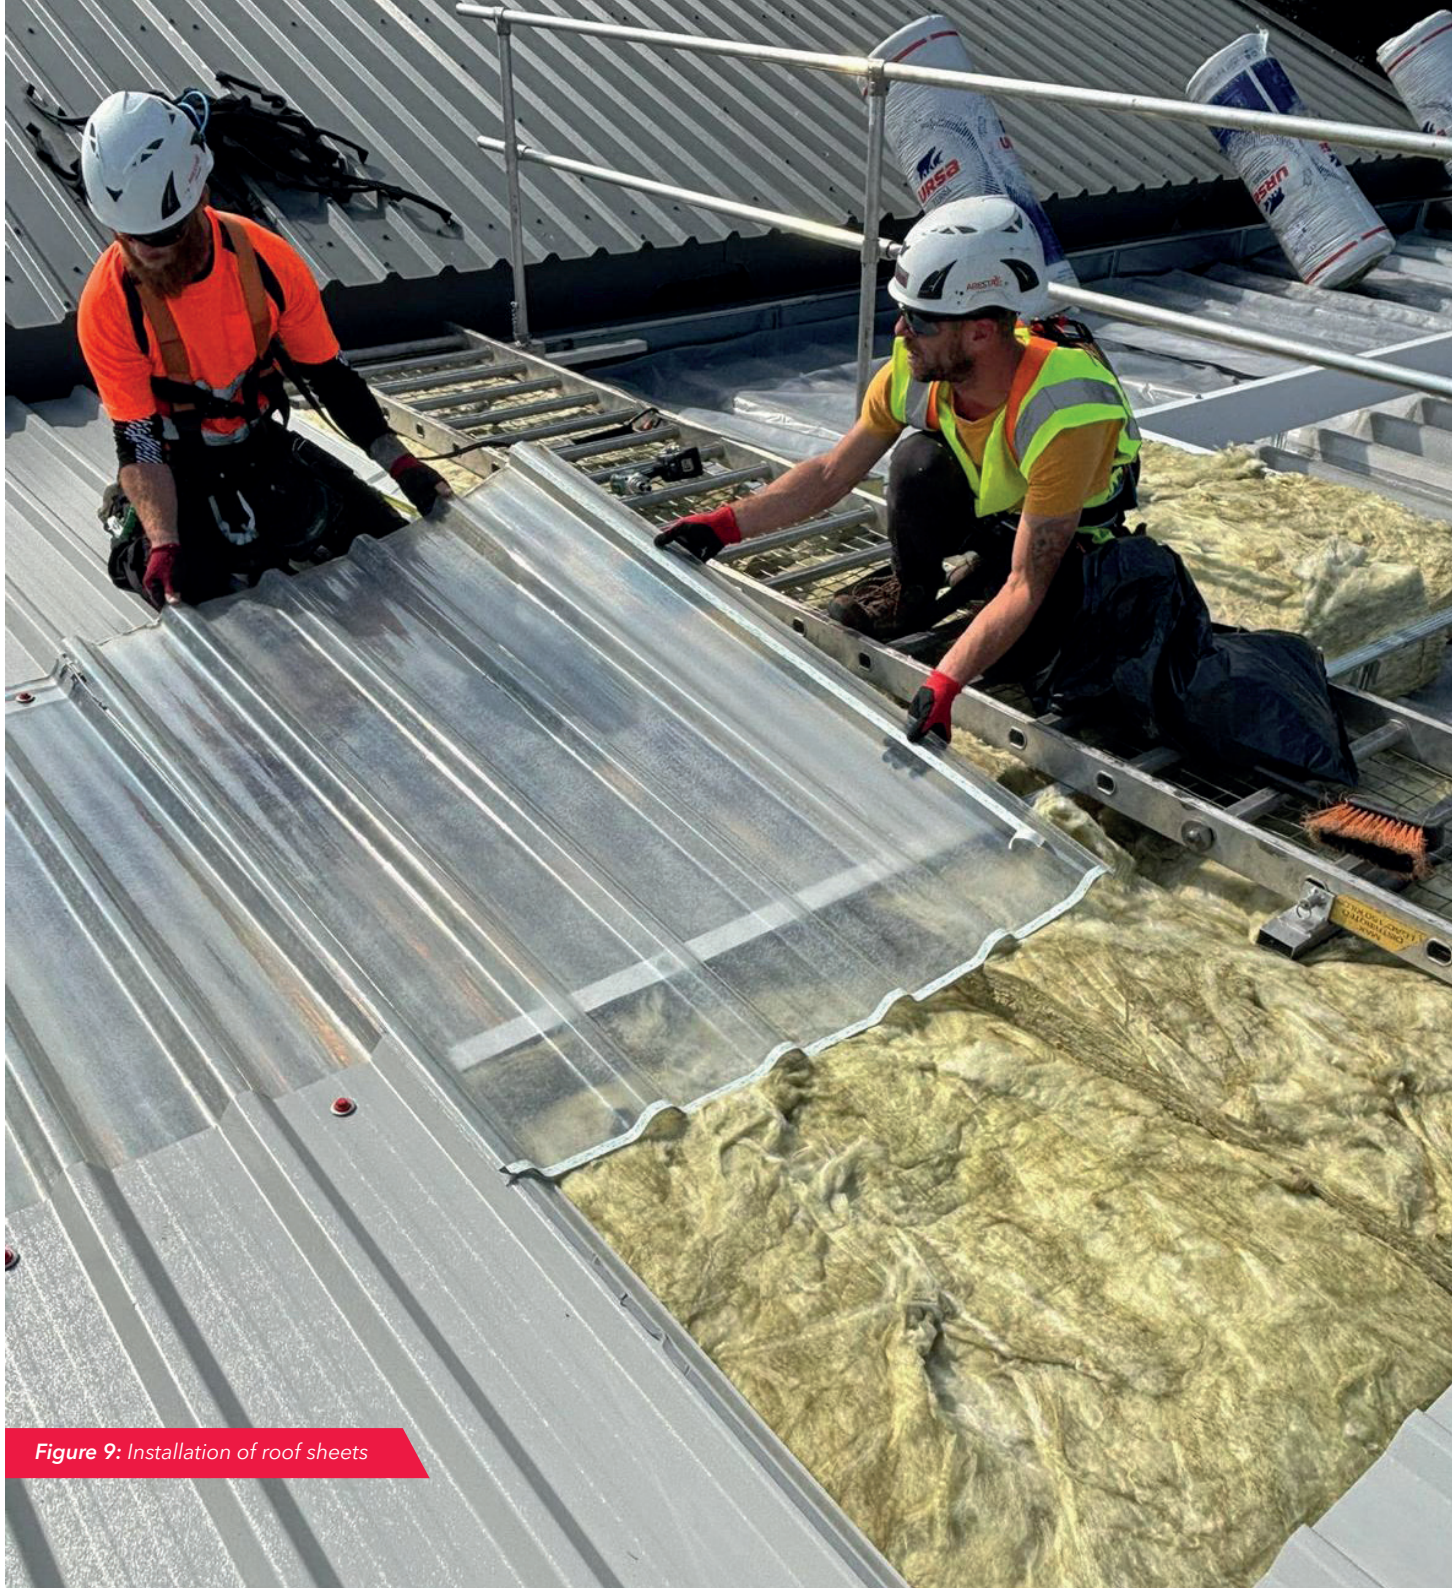
Figure 9: Installation of roof sheets

- Air and Vapour Control Layer (AVCL) installed and fully sealed.
- Mineral wool insulation laid tightly butt-jointed under the rails (*figure 9*).

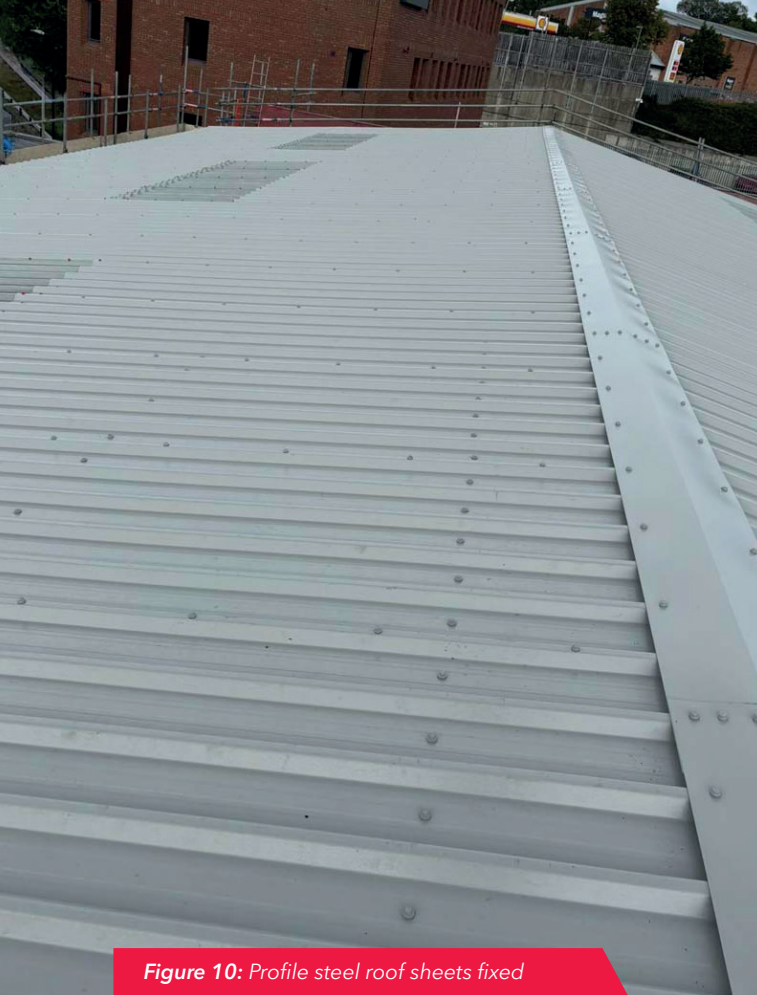
Figure 10: Profile steel roof sheets fixed

- Trapezoidal steel sheeting fixed to rails with self-drilling fixings.
- Eaves and ridge flashings installed to complete the system (figure 10).
