PCS04:
NFRC PROJECT CASE STUDY

Controlling the combustible insulation risk during construction—Inverted warm roof installation

Retail and office space, London

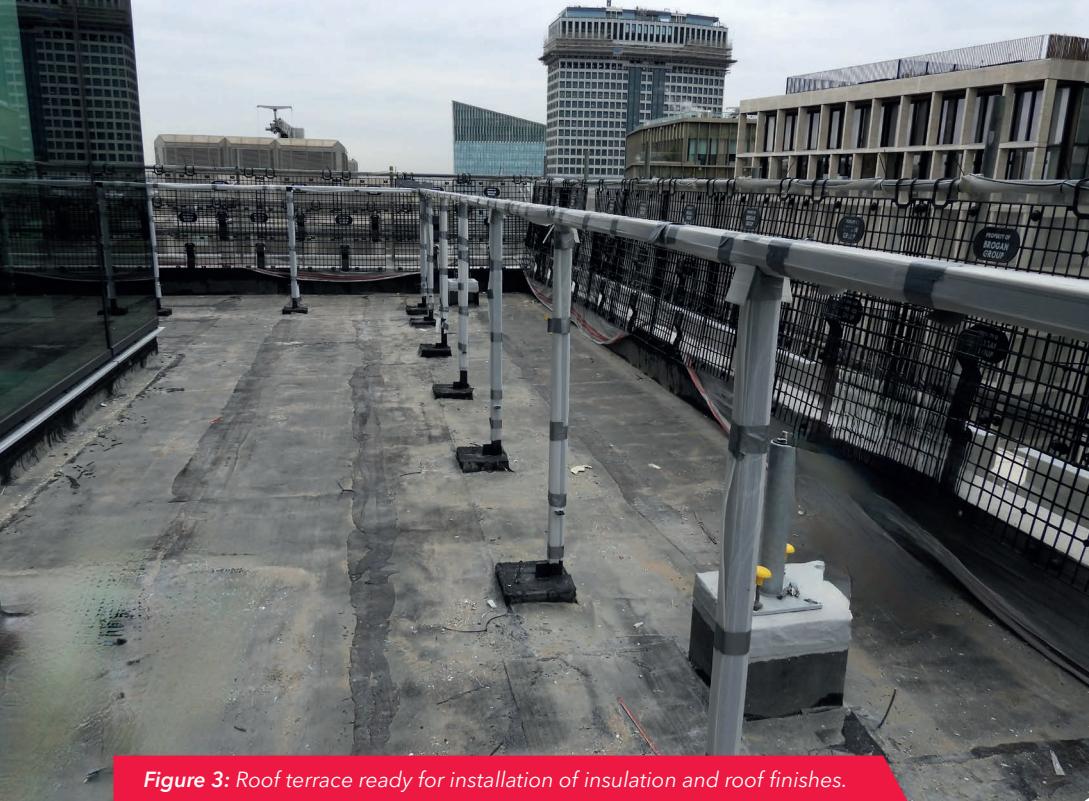
Figure 3: Roof terrace ready for installation of insulation and roof finishes.

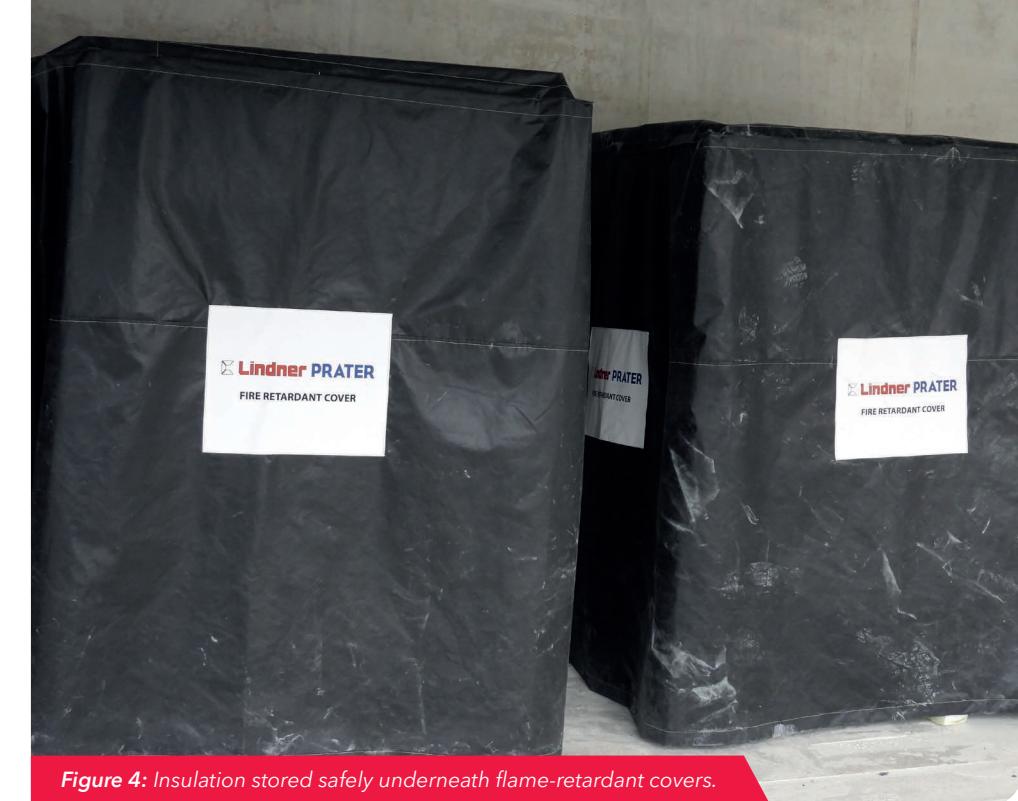
Figure 4: Insulation stored safely underneath flame-retardant covers.

Where temporary storage was unavoidable, insulation boards were kept within a clearly defined and segregated storage area, formally agreed between the contractor and the Principal Contractor. The boards were immediately protected using approved fire-retardant covers, specifically designed for packaged insulation materials. These covers provided enhanced fire resistance as well as effective weather protection, which was particularly important given the exposed conditions and constraints associated with a dense urban environment.

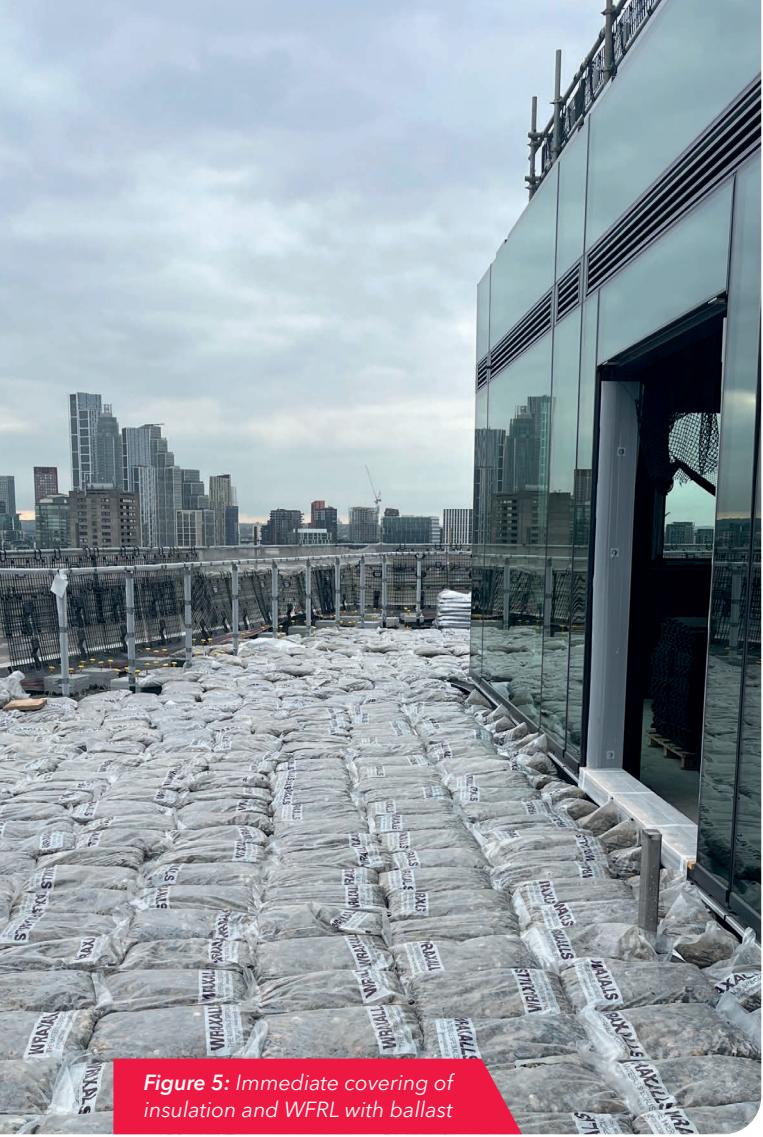
Figure 5: Immediate covering of insulation and WFR with ballast

The contractor's safe system of work ensured that the insulation and Water Flow Reducing Layer (WFRL) were immediately protected through the prompt installation of 25 kg ballast bags laid across the roof surface. These were used as a temporary non-combustible encapsulation layer, providing early protection to the insulation and ensuring that it was adequately weighted to reduce the risk of wind uplift whilst the roof build-up remained in a temporary state. This approach minimised the period during which combustible materials were exposed and reduced fire loading at roof level, pending the installation of the permanent supporting framework and paving.

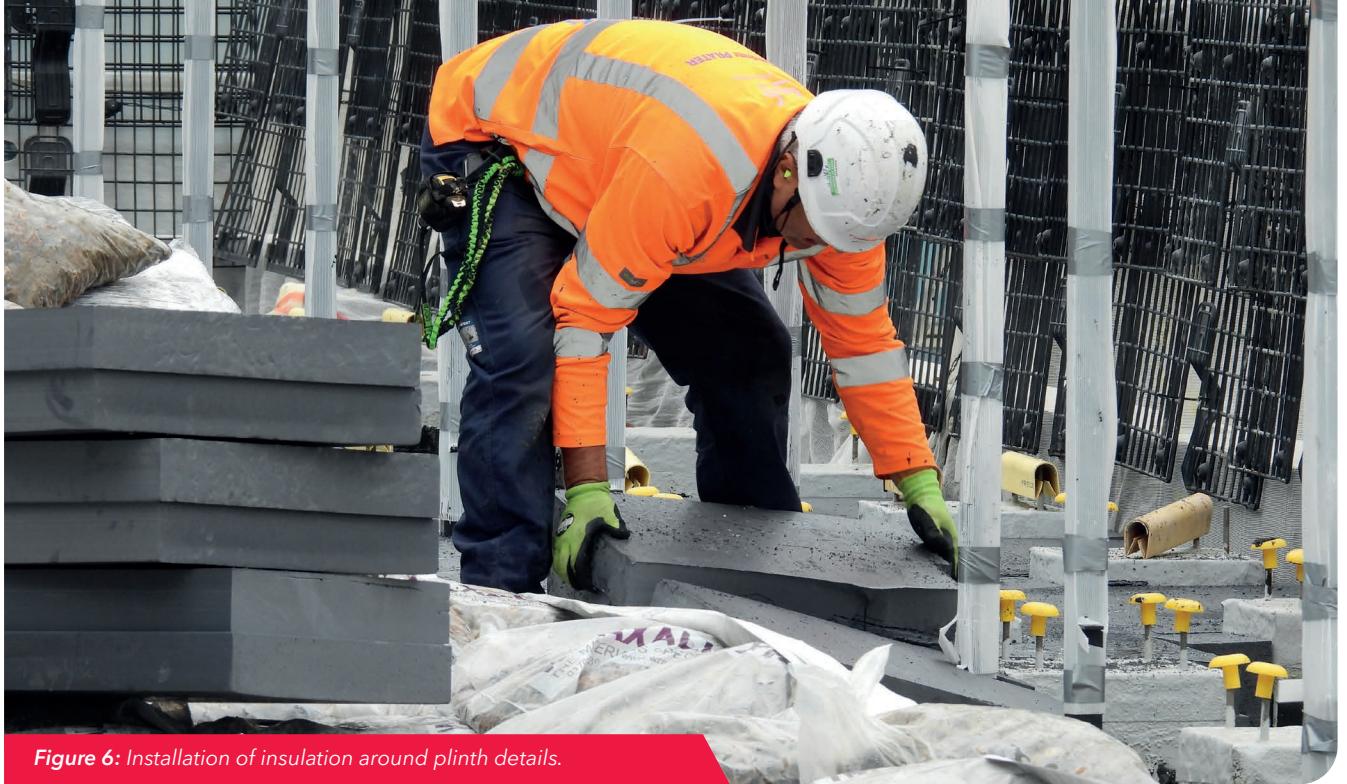
Figure 6: Installation of insulation around plinth details.

By ensuring that the insulation and WFRL were promptly protected, follow-on activities, such as installing insulation boards around roof details and upstands, including plinths,

could be undertaken with confidence that the insulation was already encapsulated beneath a non-combustible protective layer.

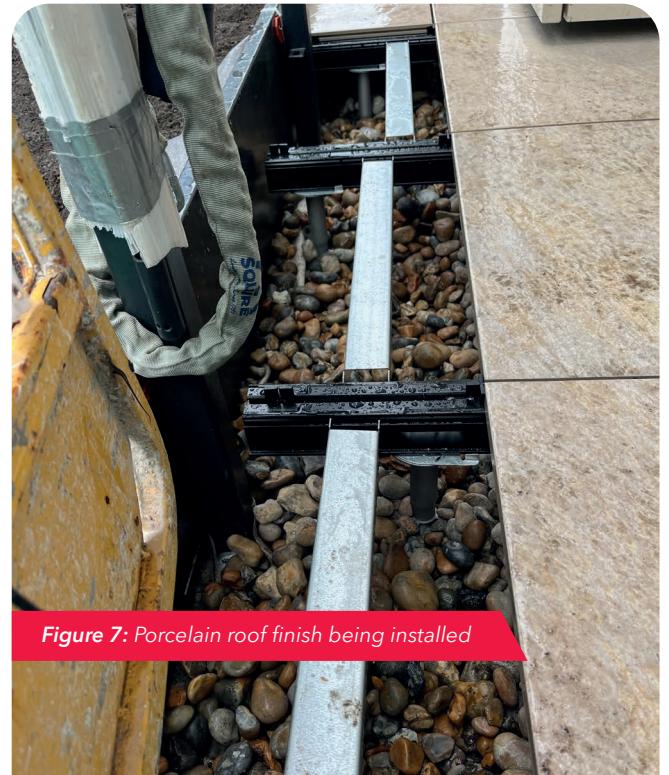
Figure 7: Porcelain roof finish being installed

Finishing trades were able to install the framework for the porcelain flagstone finish without compromising the fire performance of the roof system. This sequencing ensured that subsequent works could proceed without re-exposing combustible materials, maintaining the integrity of the fire strategy throughout the construction phase.
