PCS04:
NFRC PROJECT CASE STUDY

Controlling the combustible insulation risk during construction—Inverted warm roof installation

Retail and office space, London

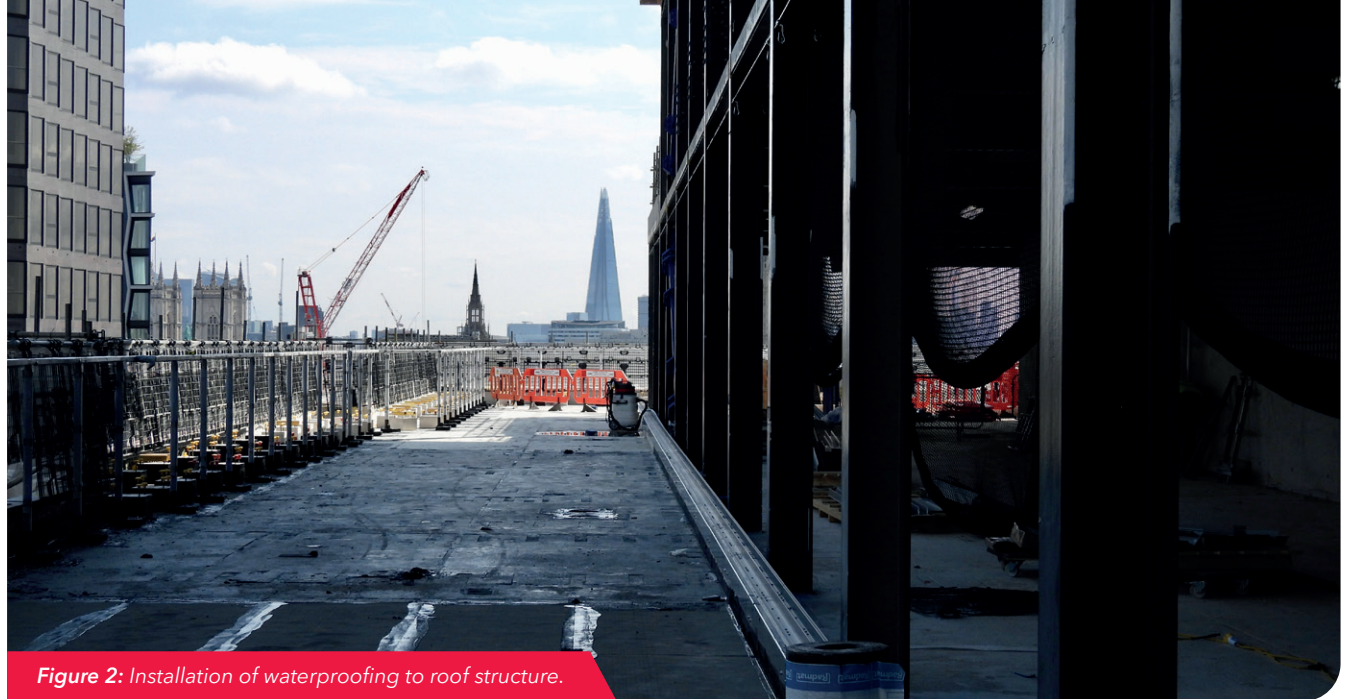
Figure 2: Installation of waterproofing to roof structure.

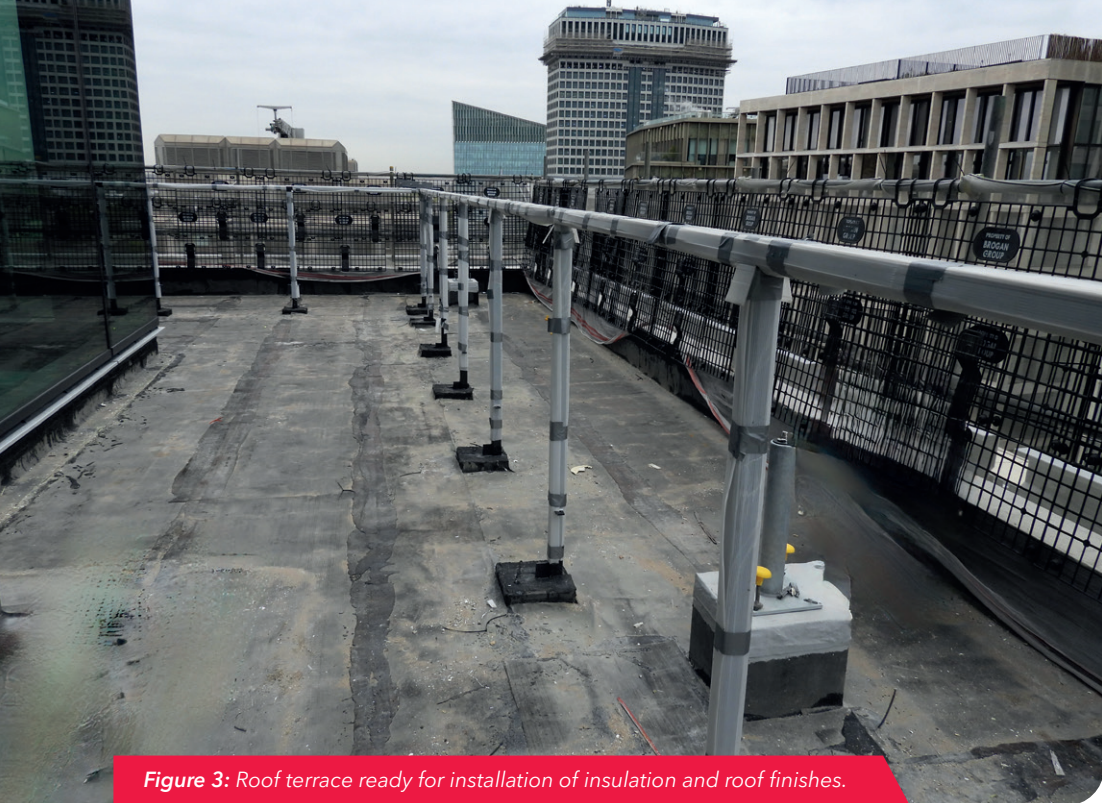
Figure 3: Roof terrace ready for installation of insulation and roof finishes.

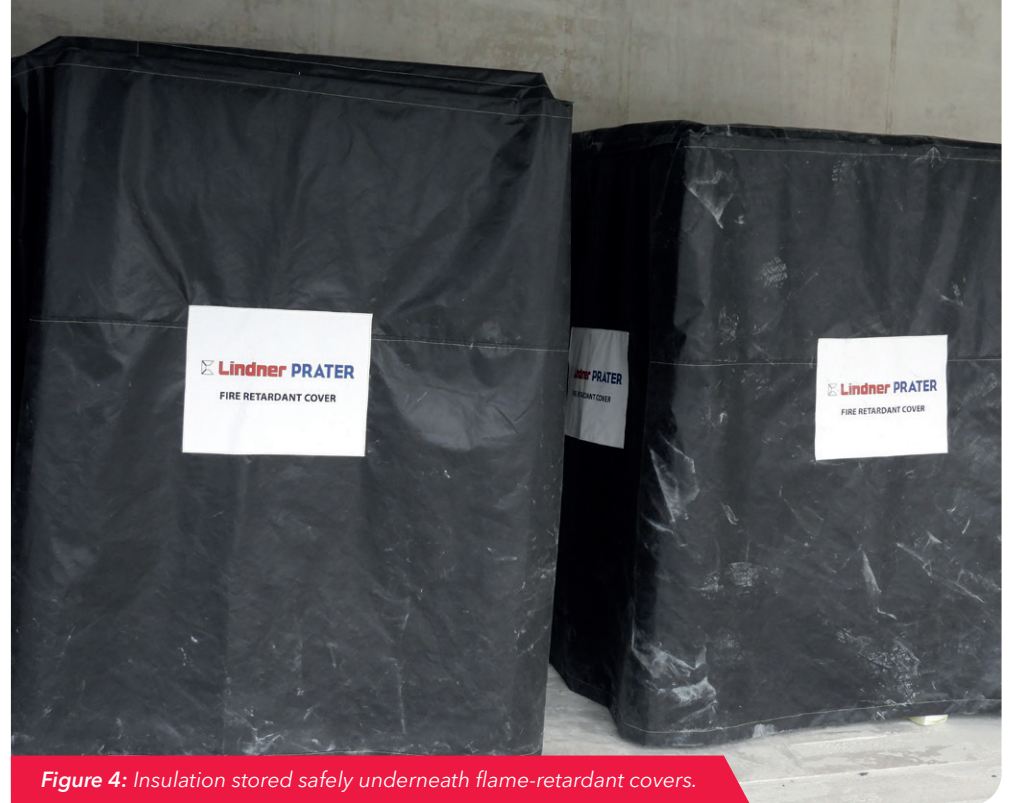
Figure 4: Insulation stored safely underneath flame-retardant covers.

Where temporary storage was unavoidable, insulation boards were kept within a clearly defined and segregated storage area, formally agreed between the contractor and the Principal Contractor. The boards were immediately protected using approved fire-retardant covers, specifically designed for packaged insulation materials. These covers provided enhanced fire resistance as well as effective weather protection, which was particularly important given the exposed conditions and constraints associated with a dense urban environment.

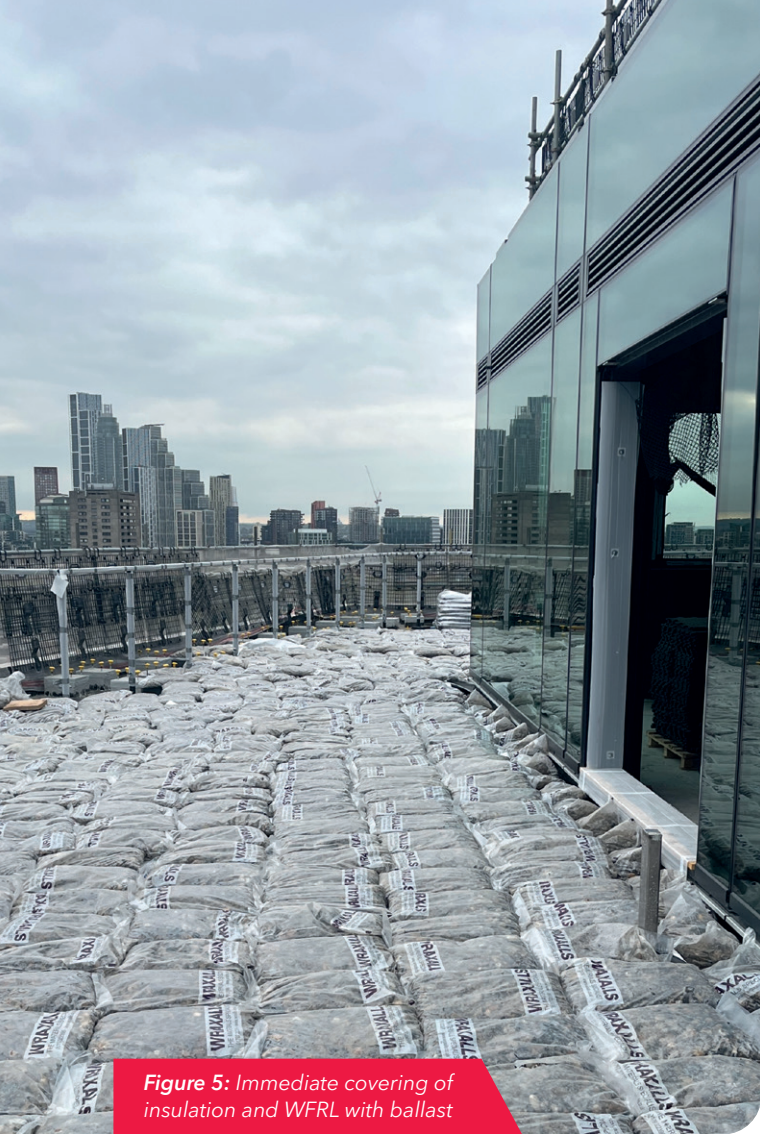
Figure 5: Immediate covering of insulation and WFRL with ballast

The contractor's safe system of work ensured that the insulation and Water Flow Reducing Layer (WFRL) were immediately protected through the prompt installation of 25 kg ballast bags laid across the roof surface. These were used as a temporary non-combustible encapsulation layer, providing early protection to the insulation and ensuring that it was adequately weighted to reduce the risk of wind uplift whilst the roof build-up remained in a temporary state. This approach minimised the period during which combustible materials were exposed and reduced fire loading at roof level, pending the installation of the permanent supporting framework and paving.

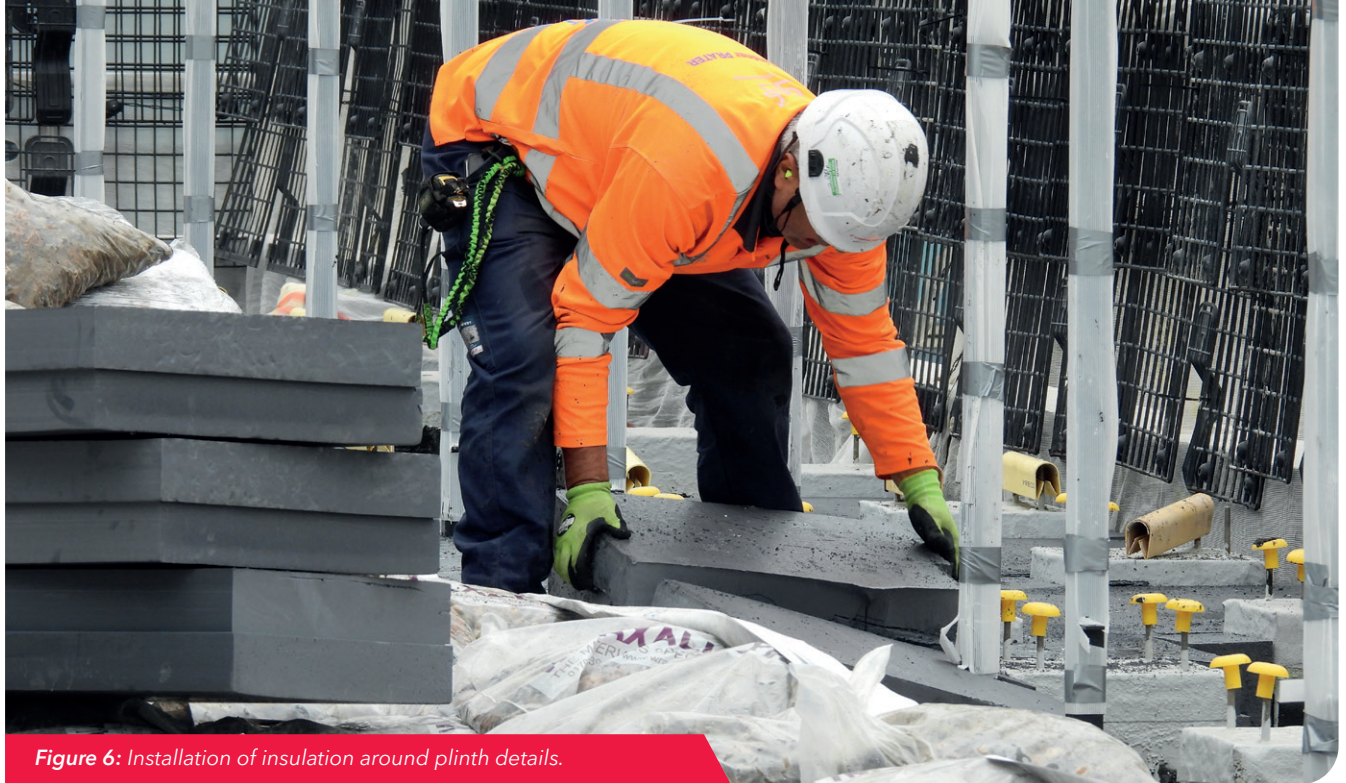
Figure 6: Installation of insulation around plinth details.

By ensuring that the insulation and WFRL were promptly protected, follow-on activities, such as installing insulation boards around roof details and upstands, including plinths,

could be undertaken with confidence that the insulation was already encapsulated beneath a non-combustible protective layer.

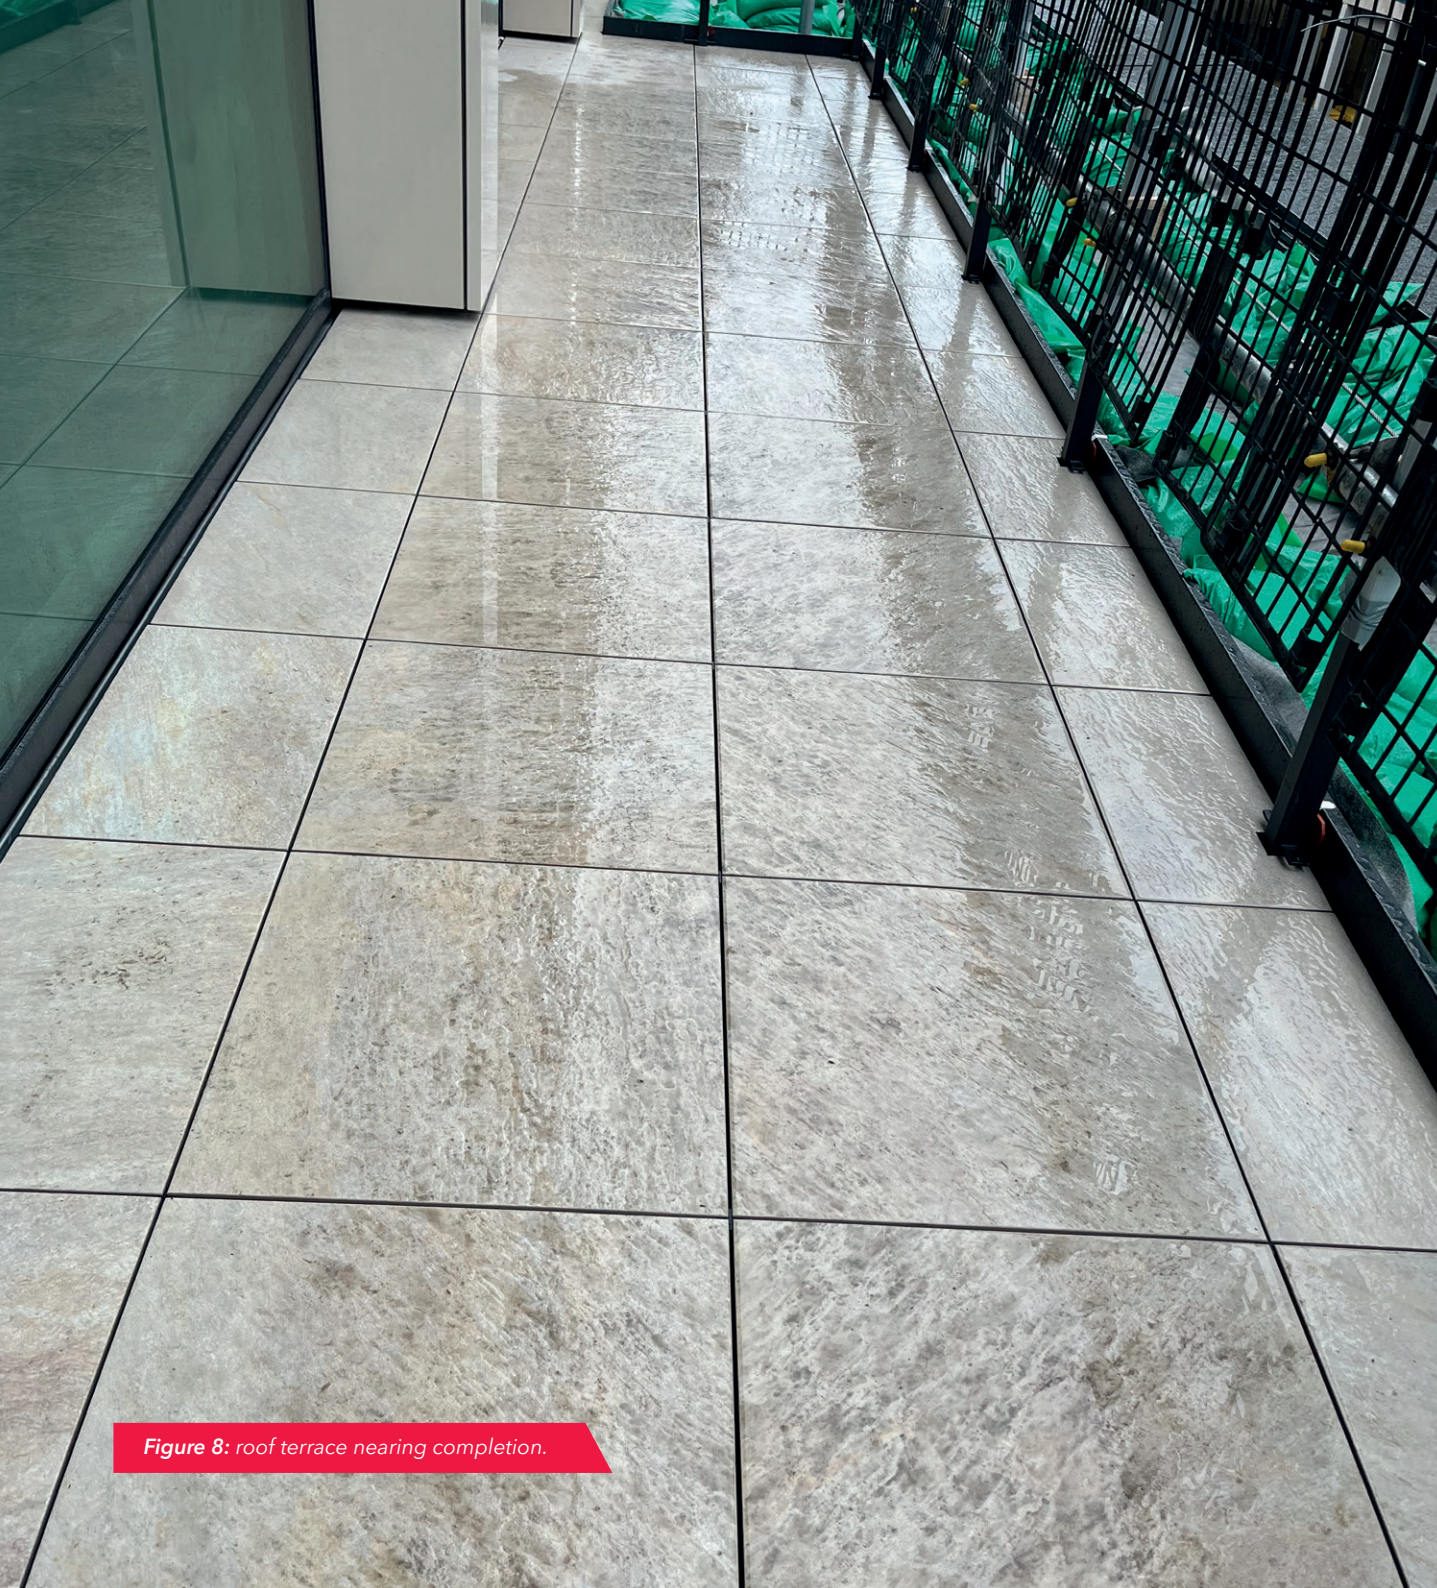
Figure 8: roof terrace nearing completion.
