## Efflorescence on concrete roof tiles: Guidance for homeowners and building owners

This guidance explains what efflorescence is, why it occurs, its effect on the performance of a roof and when further investigation may be appropriate.

This guidance applies to concrete roof tiles.

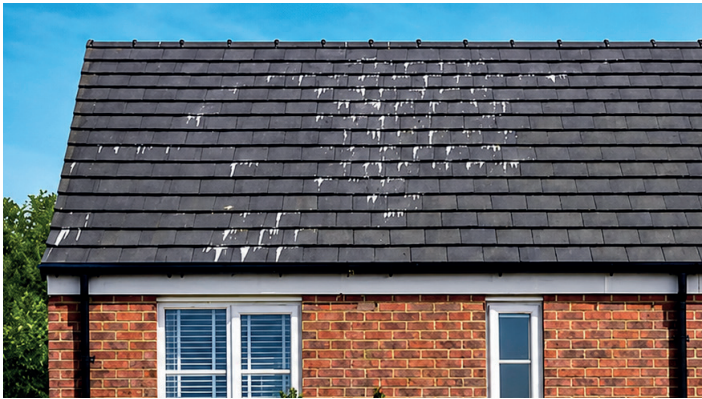
Efflorescence is the appearance of a white or light-coloured deposit on the surface of concrete roof tiles.

Concrete roof tiles are manufactured from cement, aggregates, pigments and water. During the normal curing process, naturally occurring calcium compounds are formed within the concrete. When moisture passes through the microscopic pores of the tile, small quantities of these compounds can be carried to the surface. As the moisture evaporates, the compounds react with carbon dioxide in the atmosphere to form a fine white deposit known as calcium carbonate.

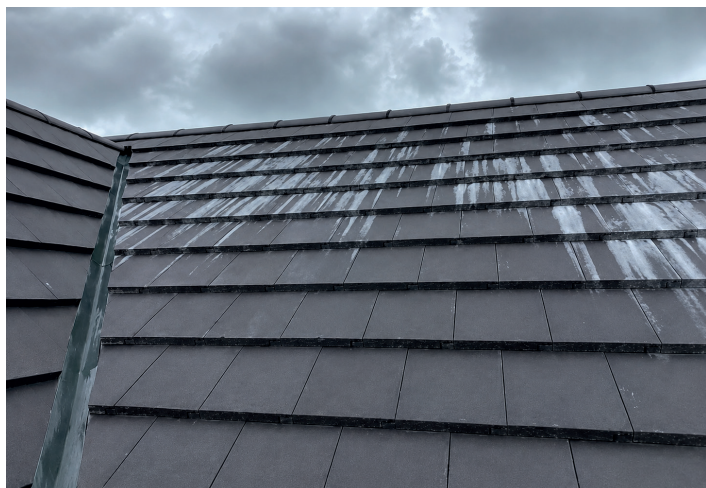
White streaks concentrated beneath ridge or hip tiles may originate from cementitious bedding mortar or pointing materials, where rainwater dissolves small quantities of free lime and carries them onto the roof surface.
